AMMRC TR 81-22

NOTCHED FATIGUE AND FRETTING FATIGUE LIFE OF TEXTURED TITANIUM

ANTHONE ZARKADES
METALS RESEARCH DIVISION

May 1981

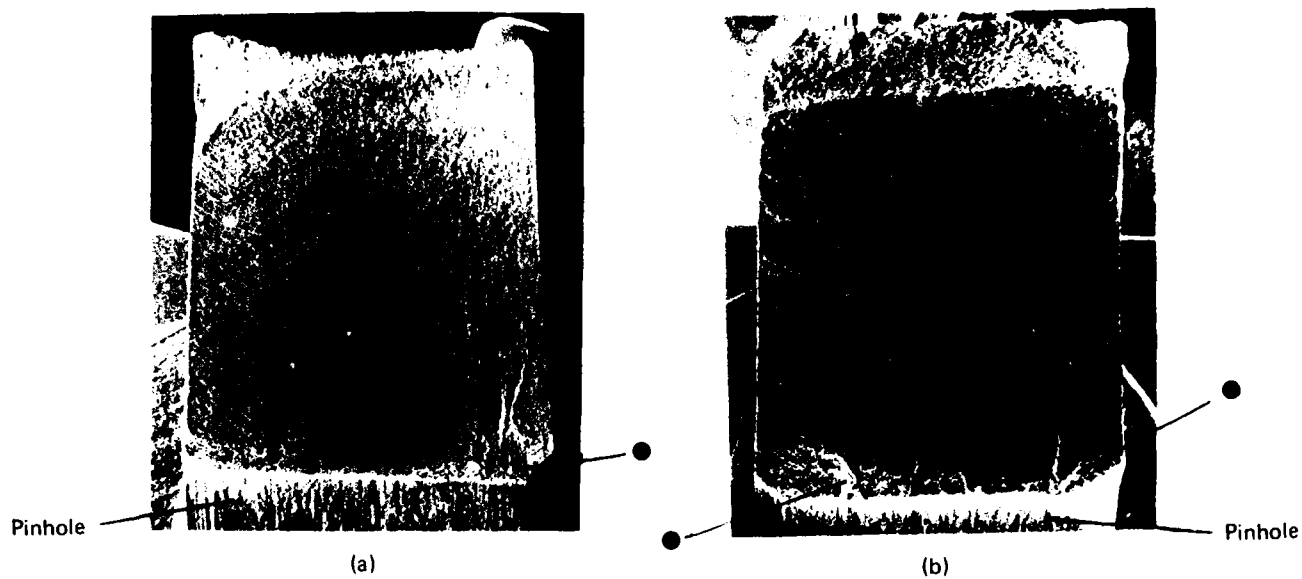
Figure 7. ● Fracture origin sites. Mag. 8.5X

Examination of the pin, pinhole, and fracture surface was conducted on the scanning electron microscope (SEM). Fracture origin sites were found to be inside the pinhole and occur at either one site, Figure 7a, or multiple sites as in Figure 7b. Closer examination of the pinhole area revealed characteristic fretting fatigue surface damage. Cavities or scars, as shown in Figure 8, were found with fatigue cracks emanating or passing through the damaged area.
